SITE NUMBER: B-R1-01
LOCAL NAME: Leyendecker
WRIA: 20.0162A

NORTH COAST OFF CHANNEL SITE INVENTORY DATA

RIVER SYSTEM: Bogachiel **DATE:** 12/20/88 **OBSERVER:** Nettnin

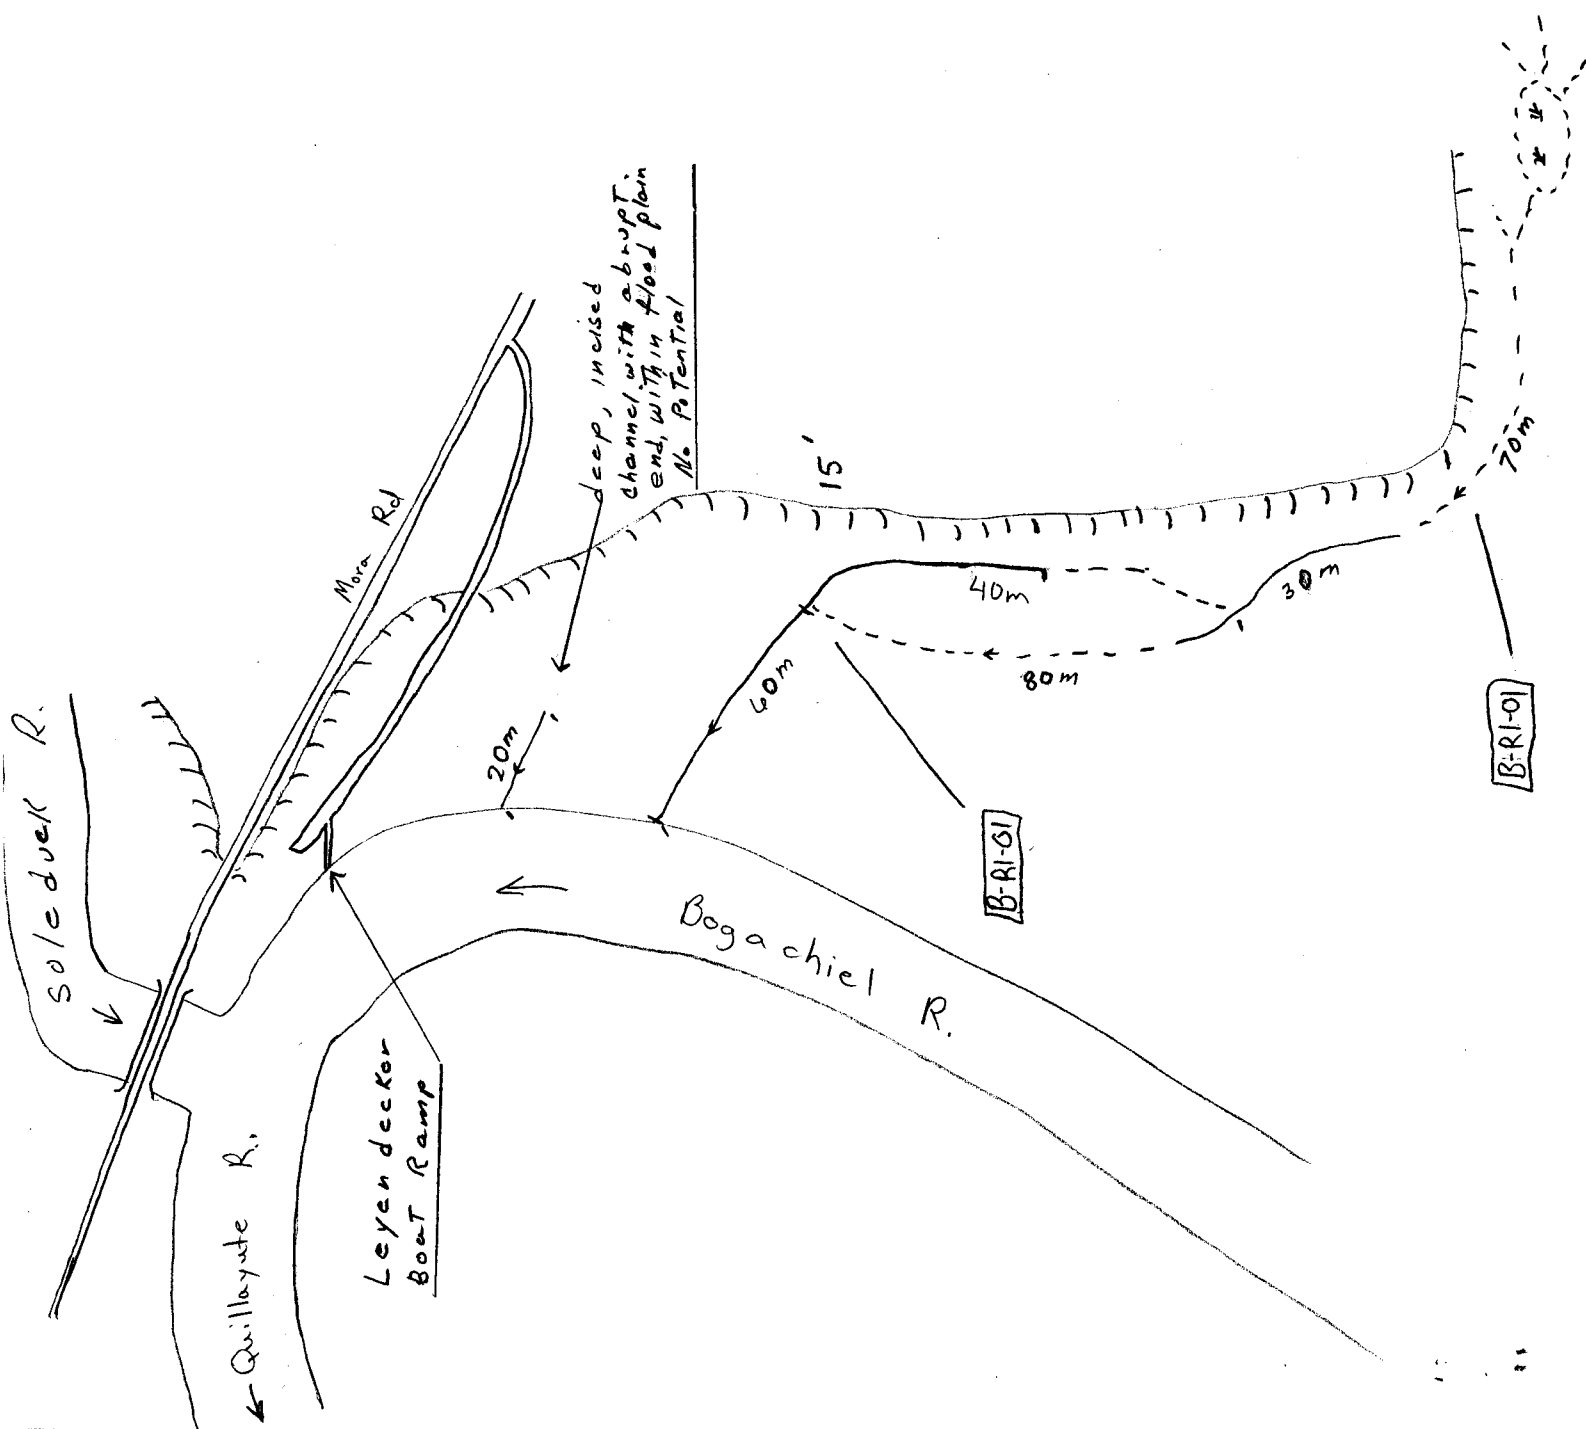
Bogachiel River
 Site: B-R1
 Channel: B-R1-01
 Layendecker
 Boat Ramp

COMMENTS & RECOMMENDATIONS: B-R1-01 is a well defined channel situated at the base of a 15 ft terrace wall. The lower 60 m of the channel (from the mouth to the base of the terrace) is deeply incised. Above this reach B-R1-01 splits into two channels that parrallel each other for about 80 m before coming together again. The left channel was dry. The lower 40 m of the right channel (nearest the base of the wall) was watered but the upper channel was dry. Above the split channel, B-R1-01 continued as a dry or intermittant channel for another 100 m before coming to a small, shallow sedge marsh. This marsh was dry at the time of this survey. No improvements can be recommended. The channel definitely appears to get inundated by low velocity flood waters. Low flows also seems to preclude any enhancement efforts. This survey was conducted within two days of a substantial rainfall. Flows in the mid reaches were already low to intermittent and the upper reach was dry.
